Parker Hill Branch Improvements

City of Boston

Boston Public Library and Public Facility Department

May 17, 2017

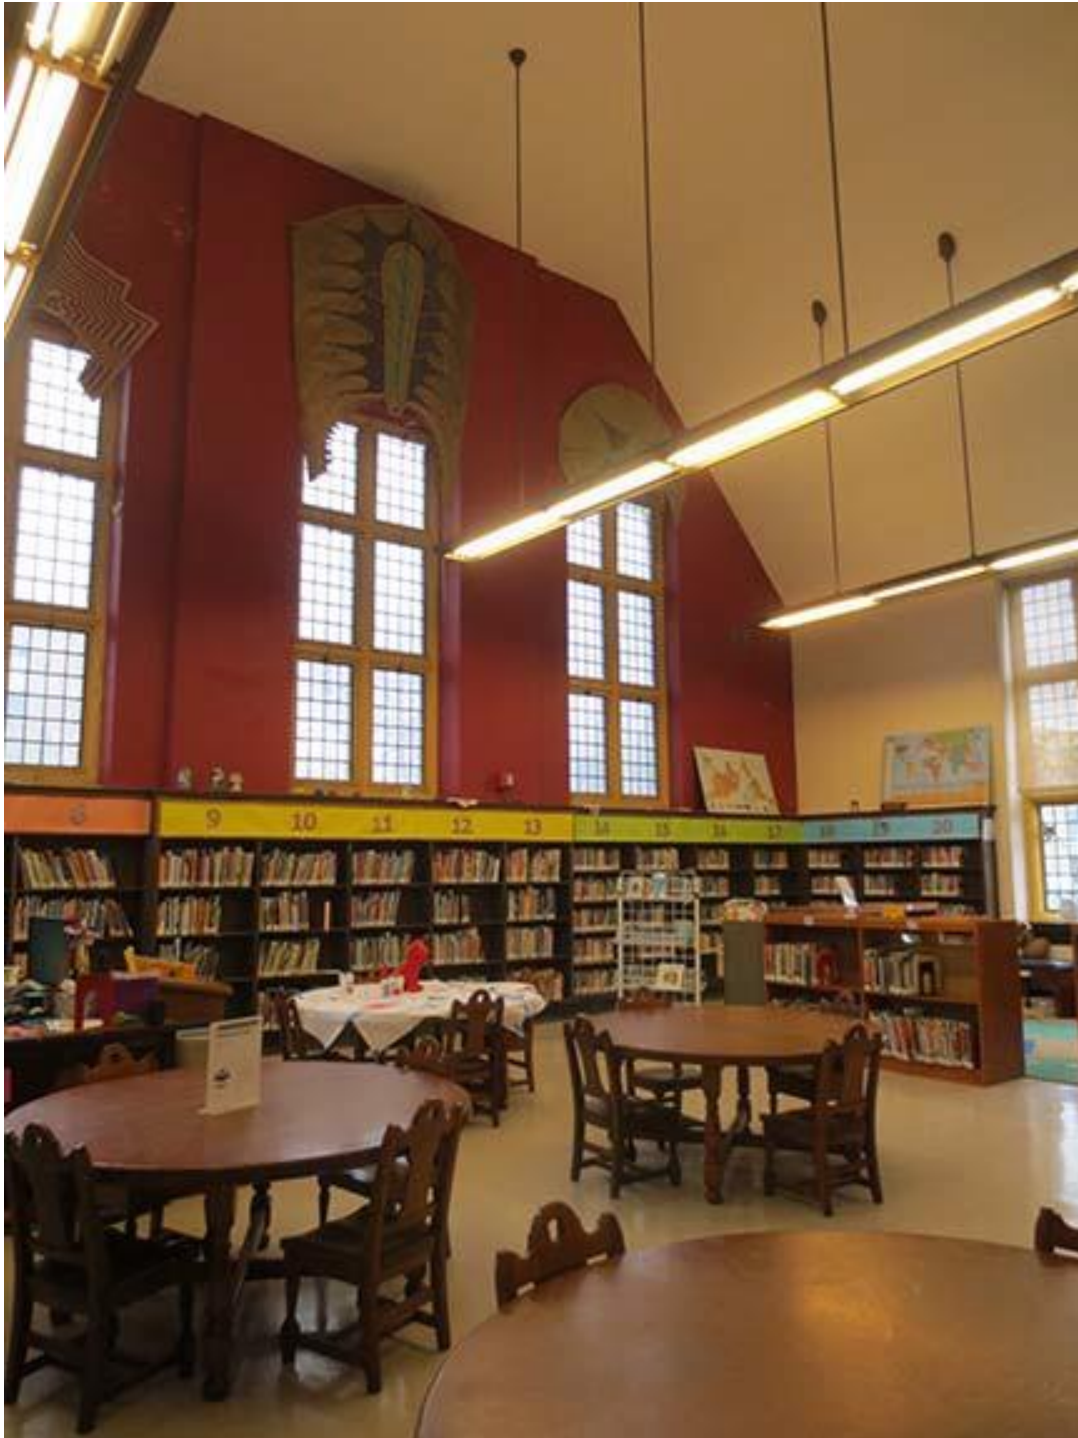
Water damage at building interior.

Water damage at main reading room.

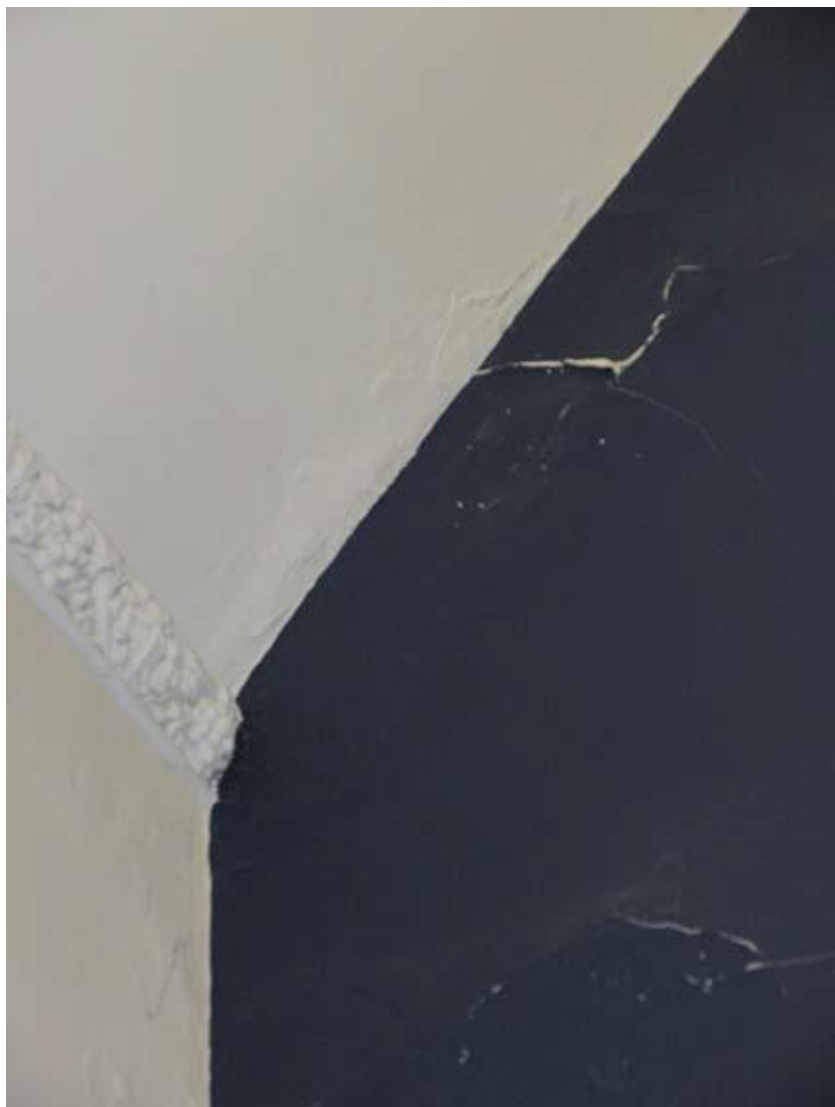
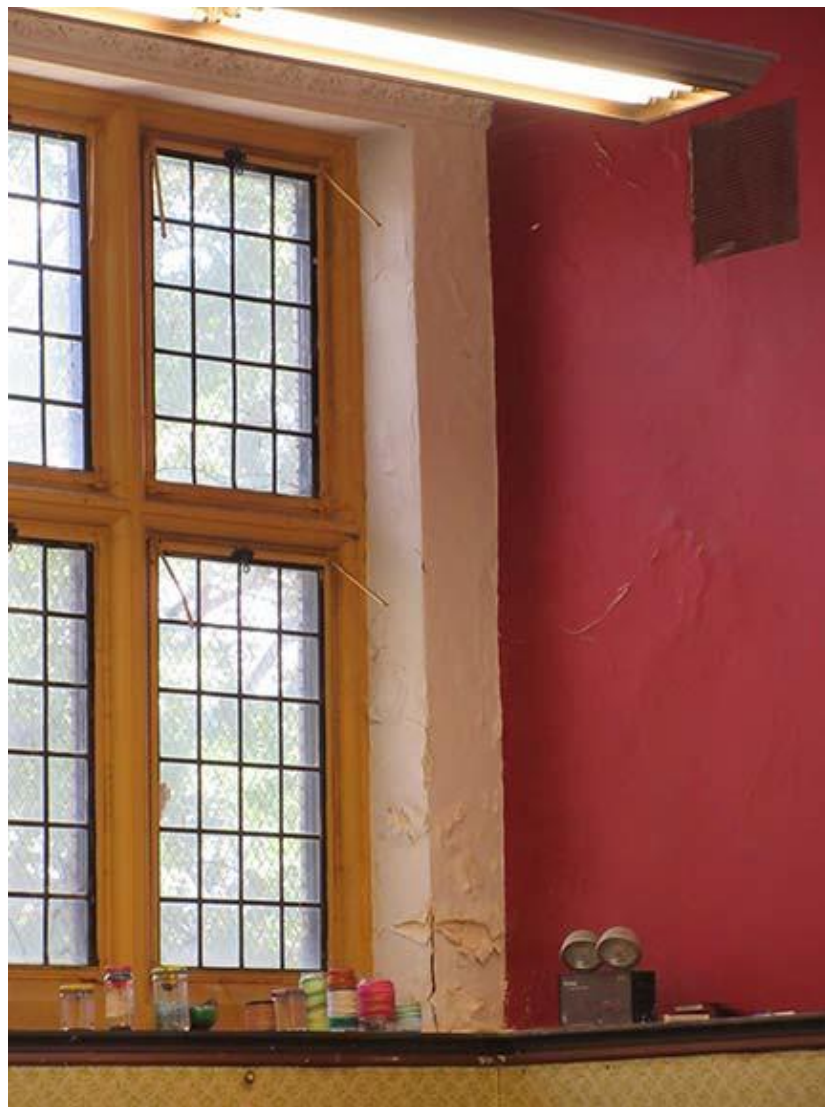
Water damage at east wall

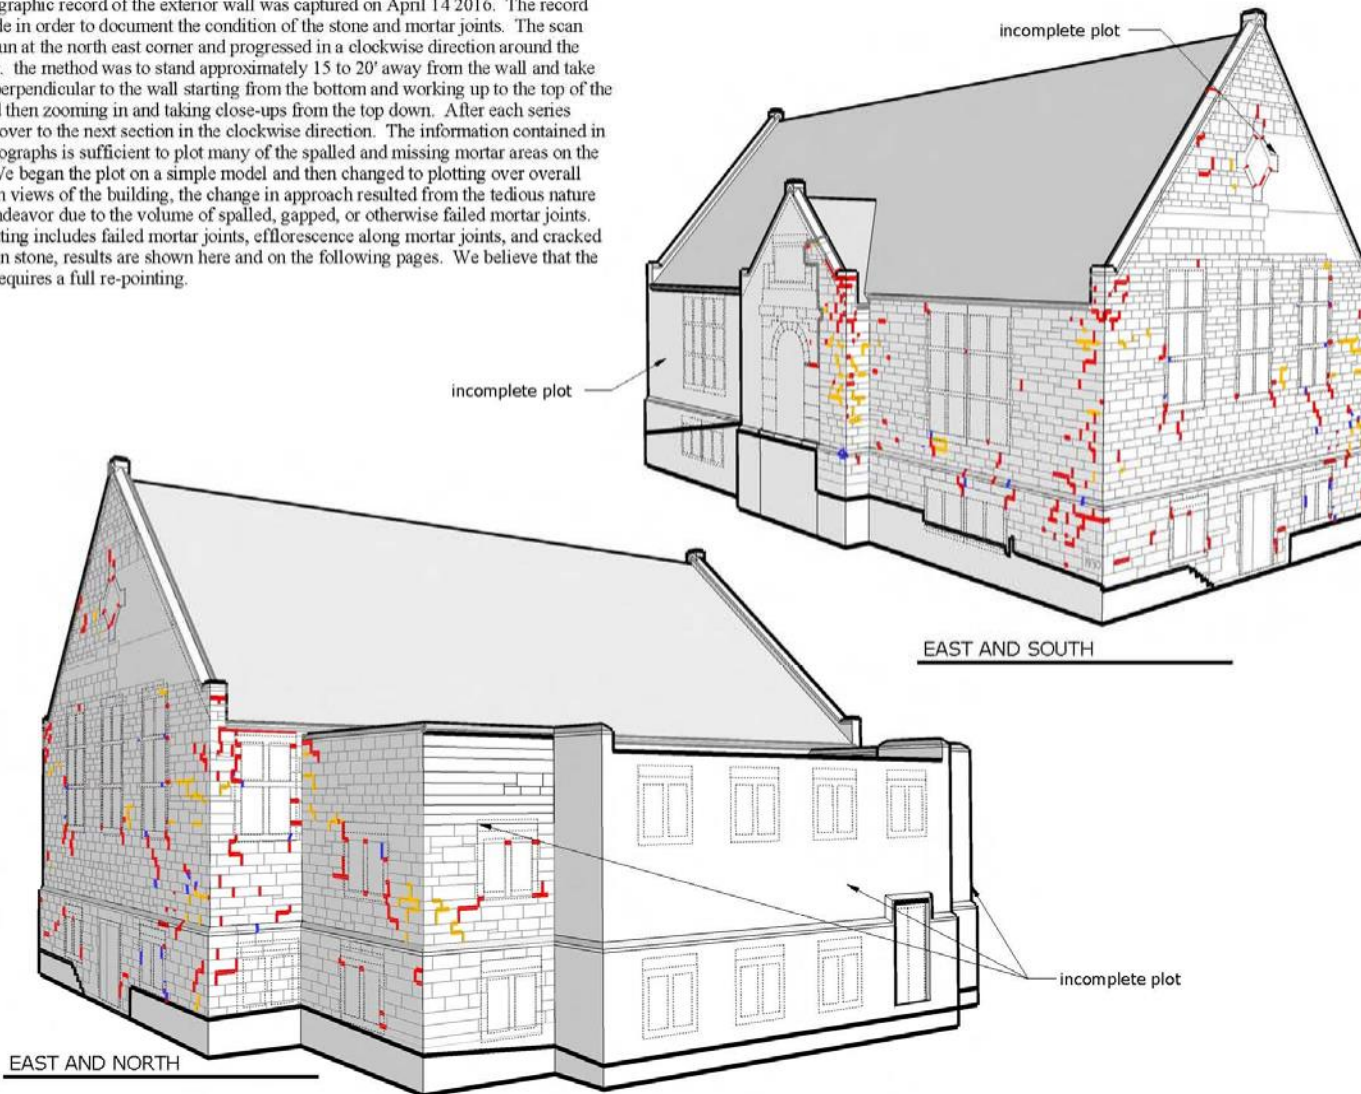
Detail #
CSP 01

Exterior Masonry - open joints and cracks in stone.

A photographic record of the exterior wall was captured on April 14 2016. The record was made in order to document the condition of the stone and mortar joints. The scan was begun at the north east corner and progressed in a clockwise direction around the building. the method was to stand approximately 15 to 20' away from the wall and take photos perpendicular to the wall starting from the bottom and working up to the top of the wall and then zooming in and taking close-ups from the top down. After each series moving over to the next section in the clockwise direction. The information contained in the photographs is sufficient to plot many of the spalled and missing mortar areas on the wall. We began the plot on a simple model and then changed to plotting over overall elevation views of the building, the change in approach resulted from the tedious nature of the endeavor due to the volume of spalled, gapped, or otherwise failed mortar joints. The plotting includes failed mortar joints, efflorescence along mortar joints, and cracked or broken stone, results are shown here and on the following pages. We believe that the mortar requires a full re-pointing.

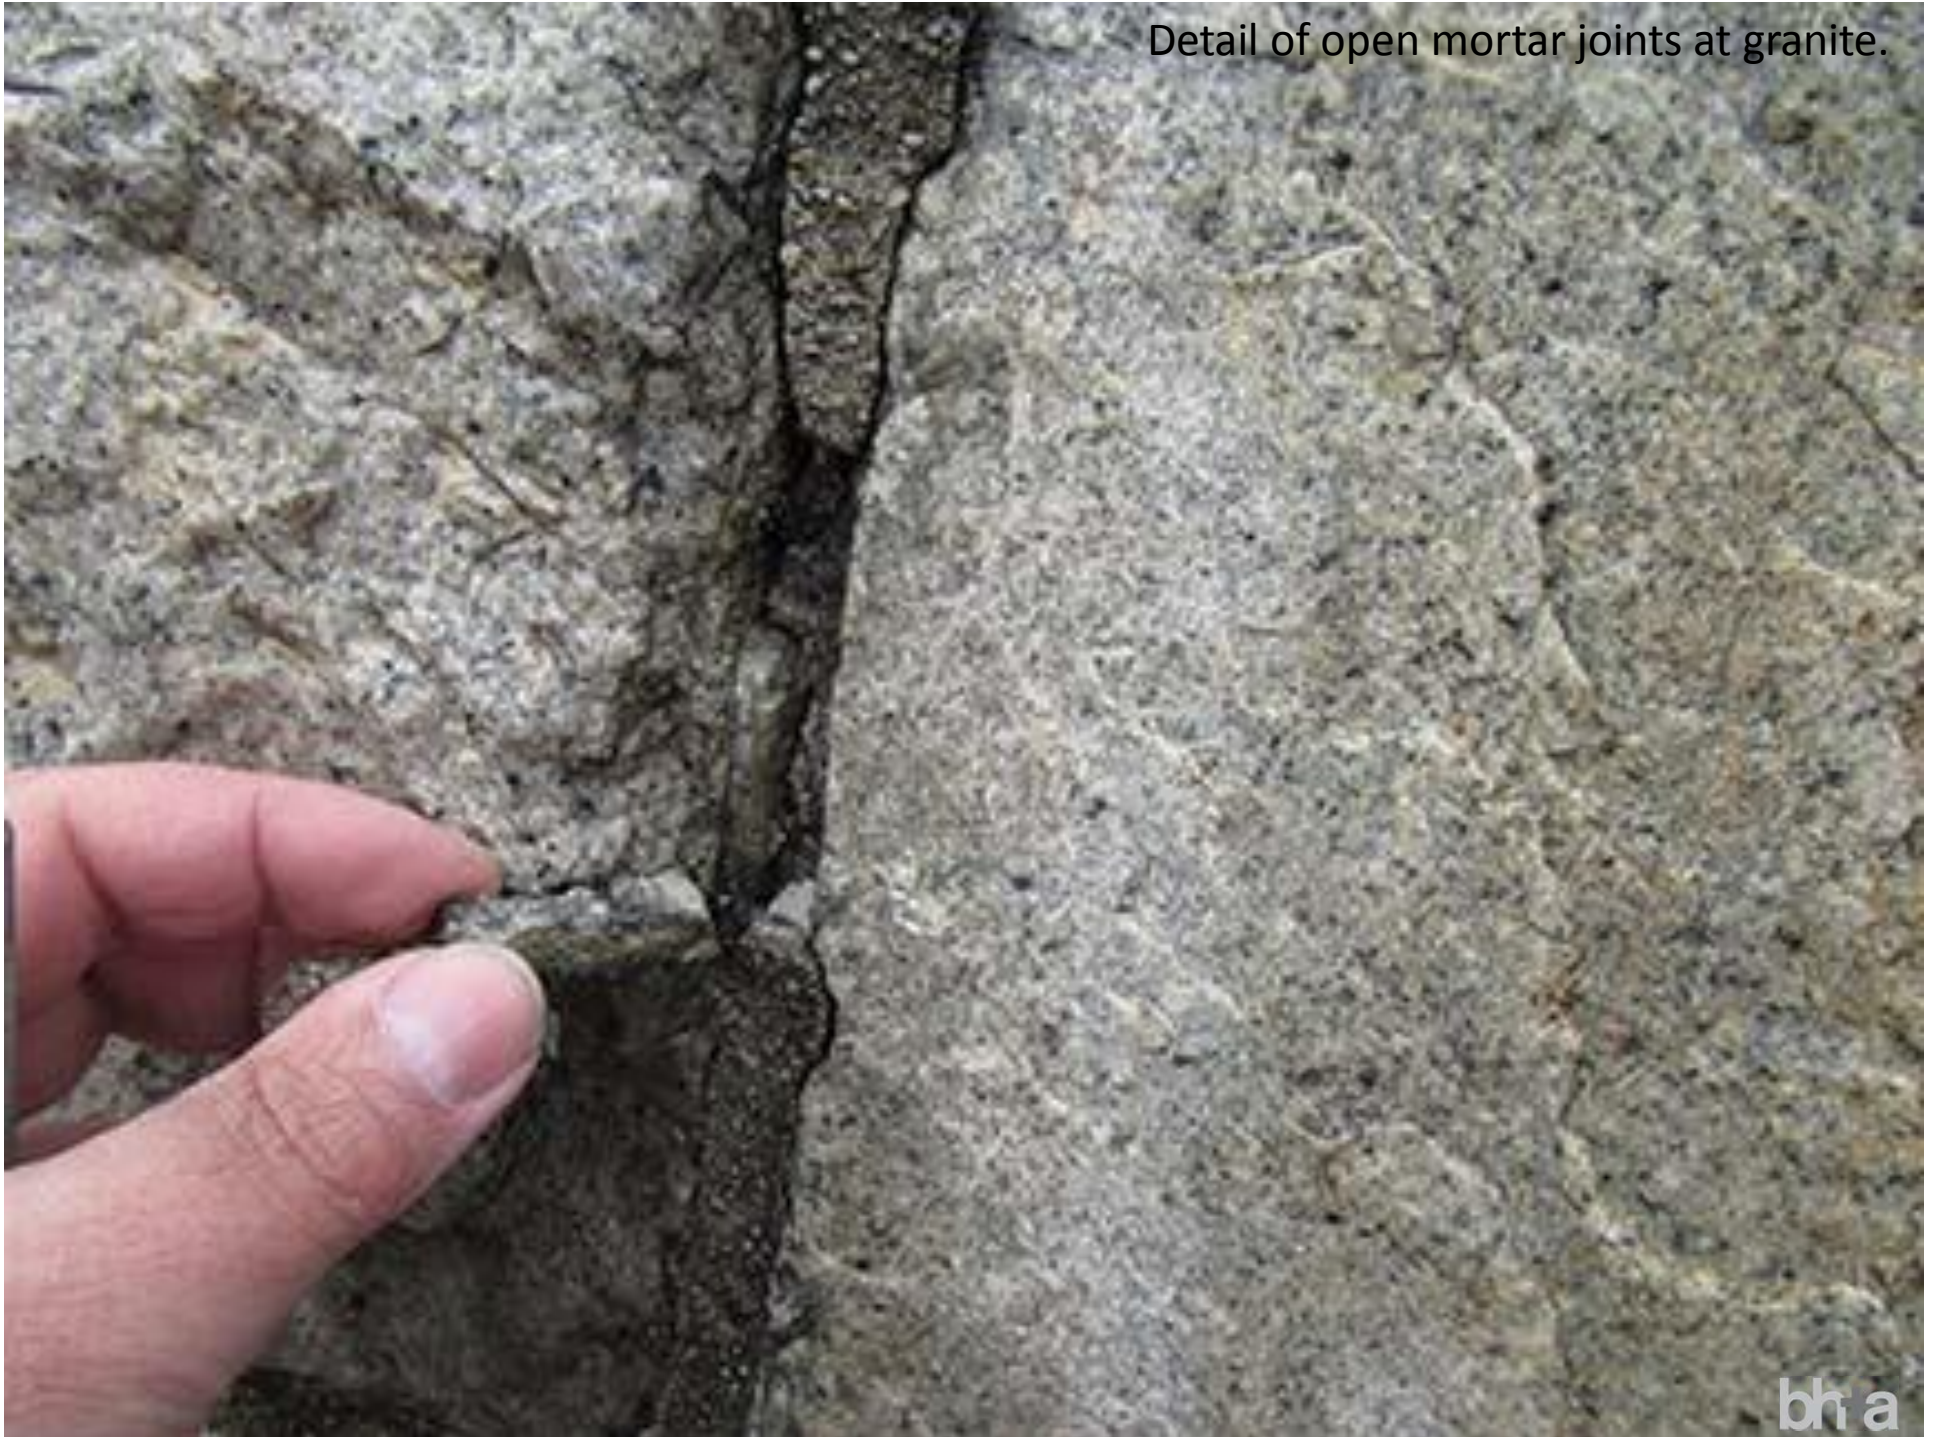
Detail of open mortar joints at granite.

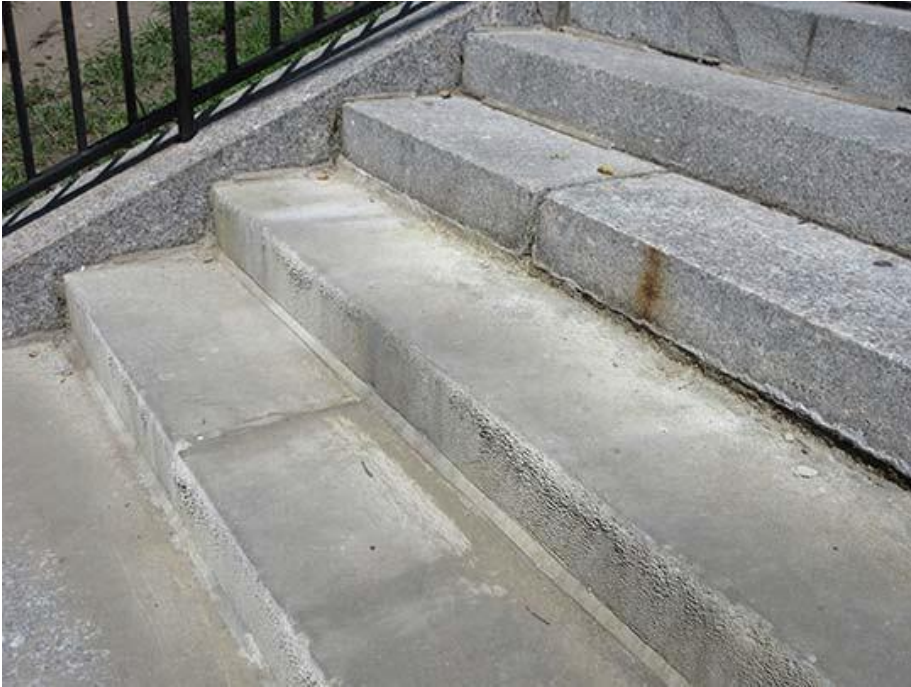
Patched treads and open joints at front steps.
Stone veneer not secured at sidewall.

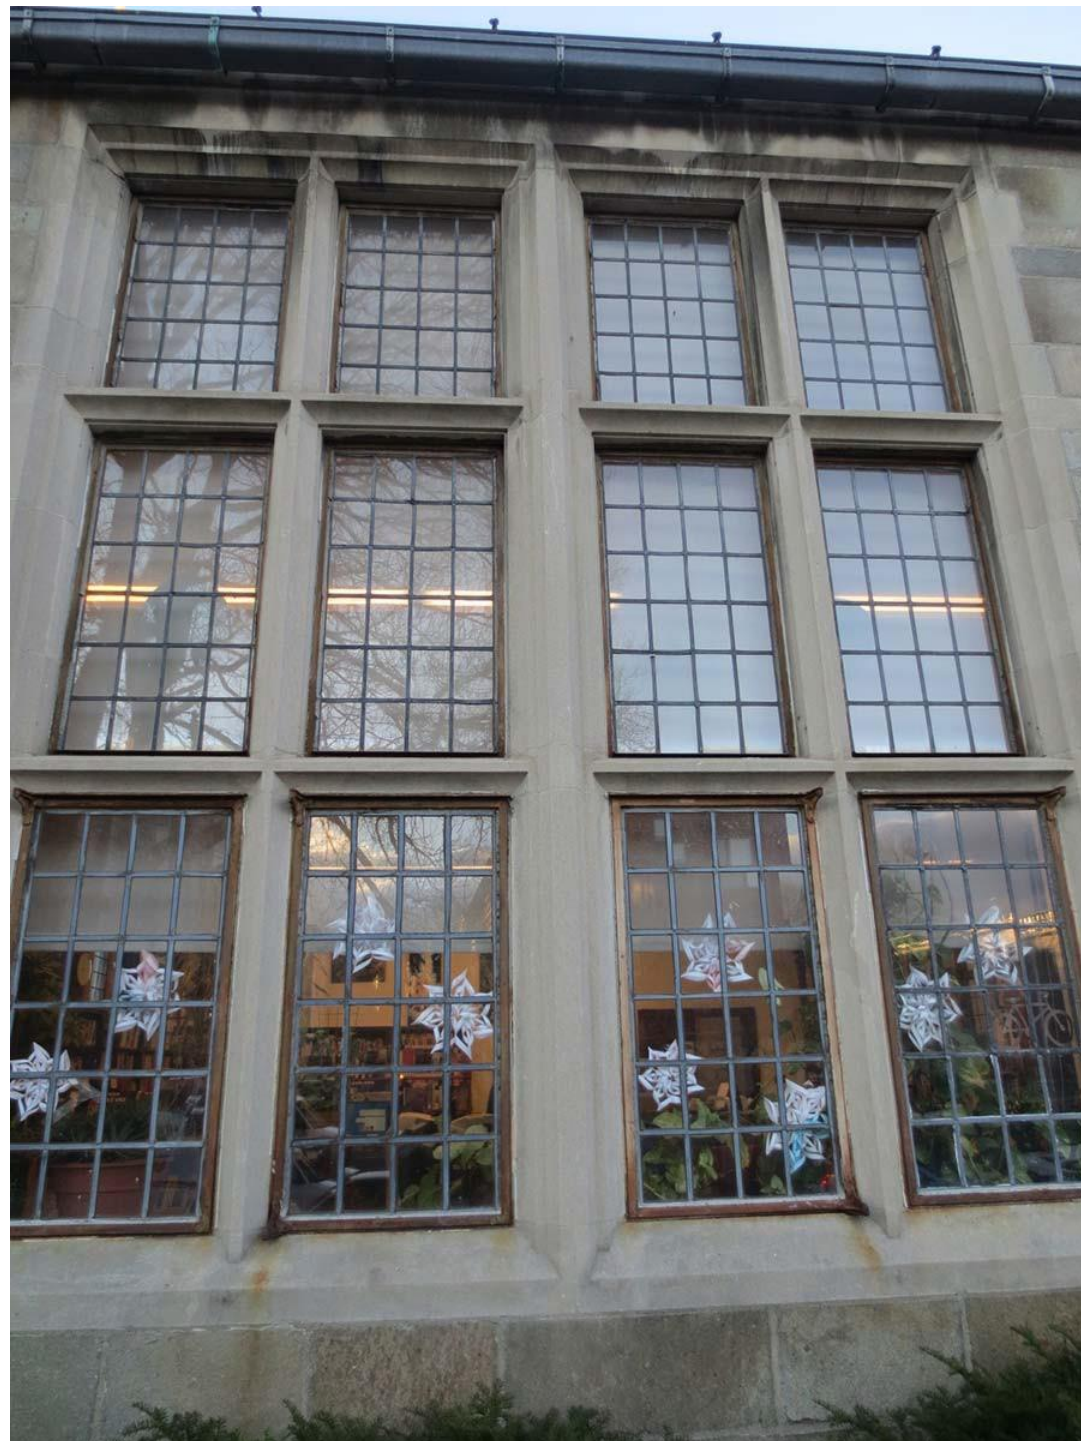
Steel at windows is rusted throughout.
