Draft report for discussion purposes only – 12/11/2014

Faneuil Branch Library EXISTING CONDITIONS

INTRODUCTION

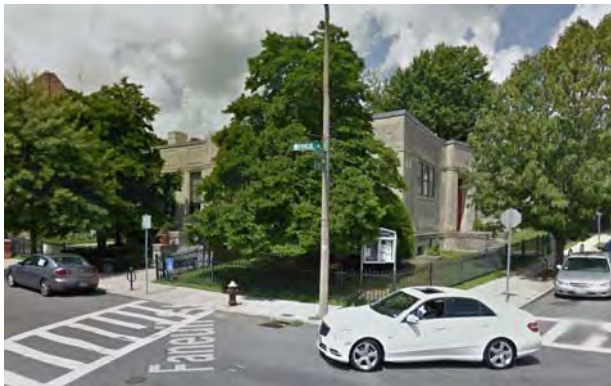
LIBRARY FRONT OBSCURED BY TREES

While these relatively mature trees are appreciated by the community of library users, they block light and views to and from the library, which are concerns relative to desires for better and more efficient lighting and improved interior environment. The leaf fall from these trees becomes a roof drain maintenance issue since they are so close to the library. The large trees are also not consistent with the historic presence of the building and diminish the building’s prominence on the square. These trees should be examined by an arborist to determine their future viability and potential replacement with a variety that does not grow so large.

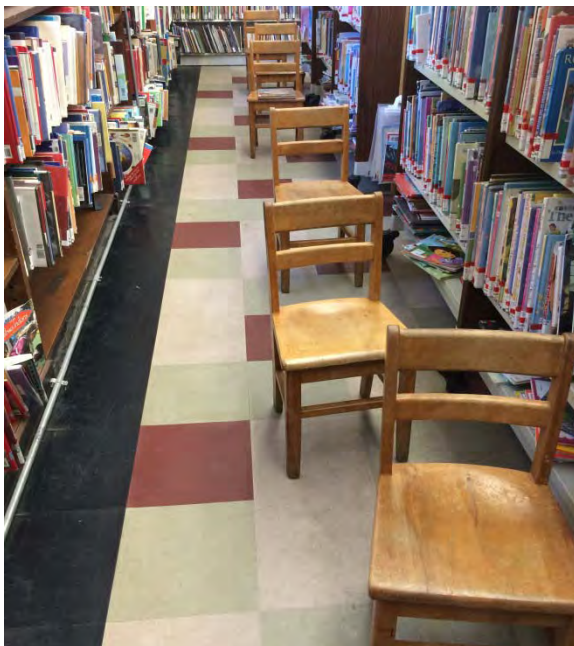
CHAIRS BLOCK COLLECTIONS

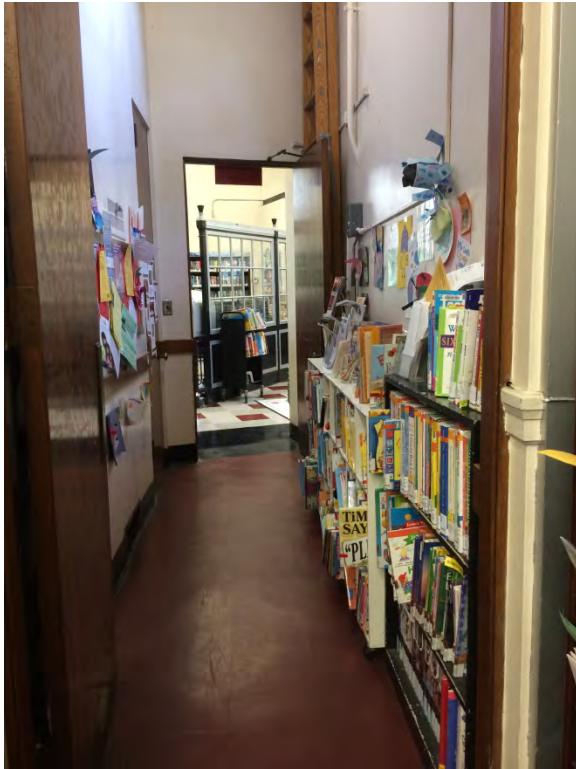
COLLECTIONS CROWD HALLWAY

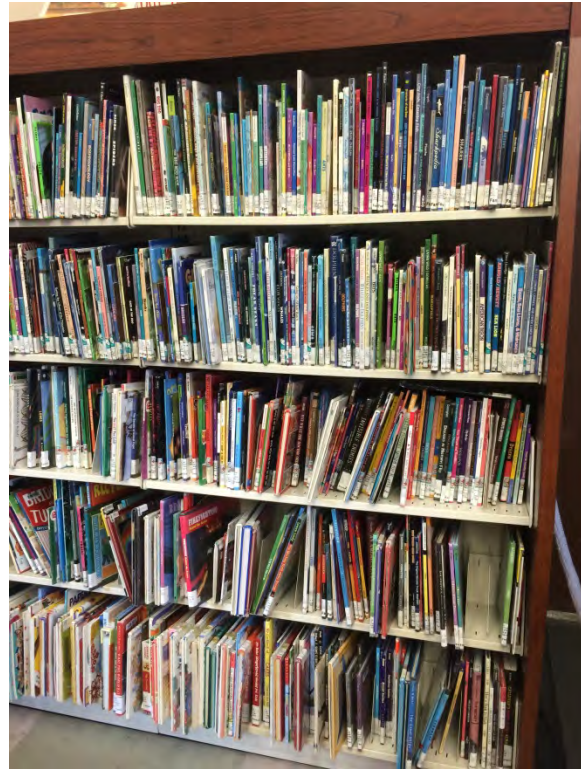
HIGH PICTURE BOOKS – NOT CHILD FRIENDLY

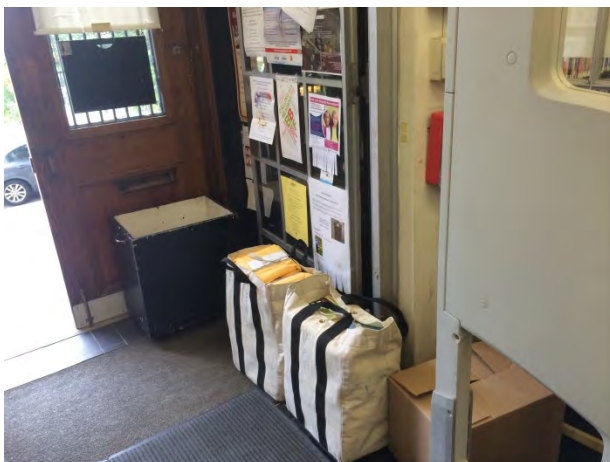
OUTGOING MATERIALS WAIT IN ENTRY AREA

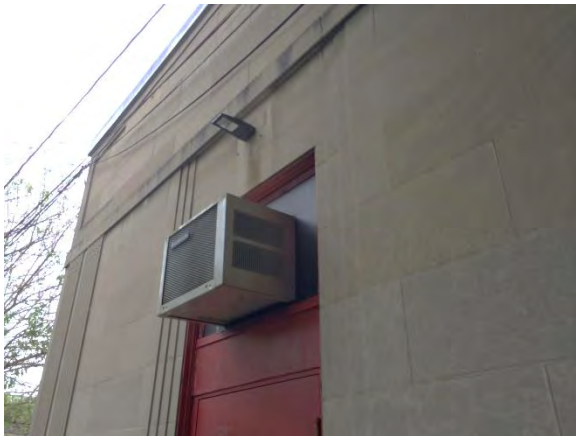
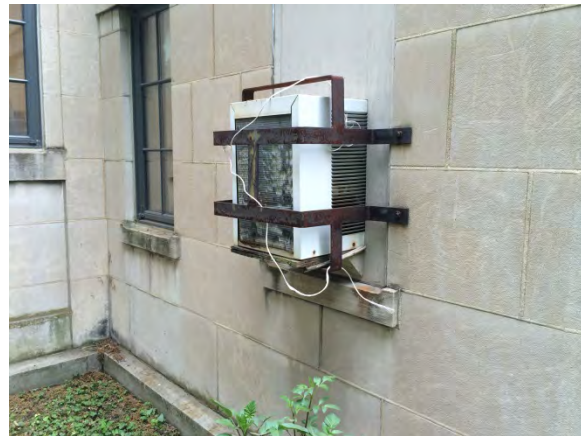
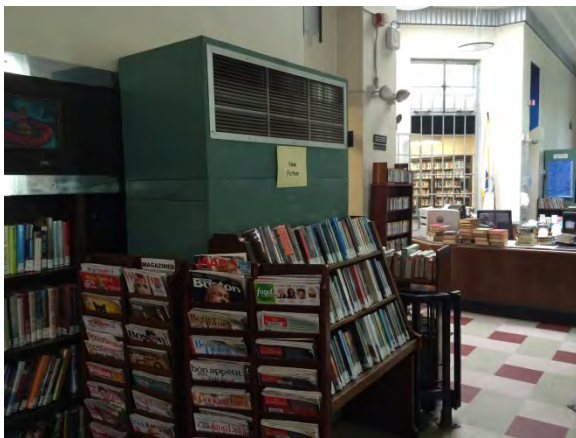
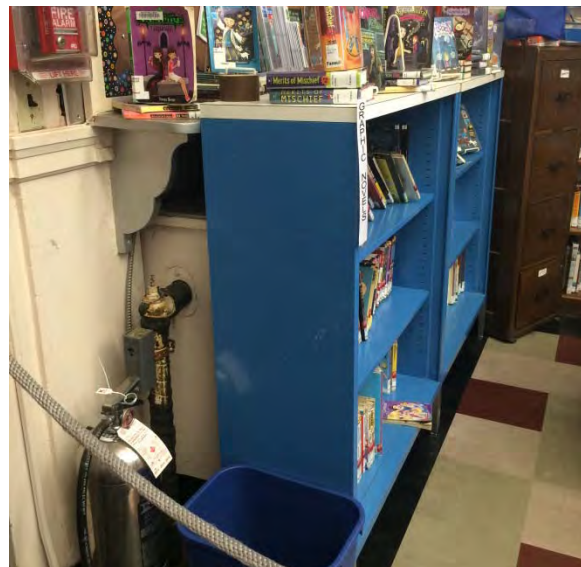
Heating Ventilating and Air-Conditioning systems are either obsolete, underperforming, in poor condition or a combination of these characteristics. Additionally, components of these systems which were added subsequent to the original construction (there was no AC originally) occupy prime space in the public areas, or are added onto the exterior of the building in unattractive ways (e.g. window air conditioners). The equipment is noisy when in operation, compromising the library's acoustic environment.

Also, collections and furnishings have been added in from of radiators, negatively impacting system performance, energy efficiency and patron comfort

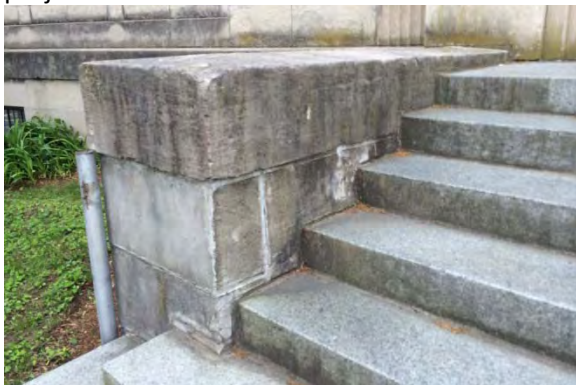
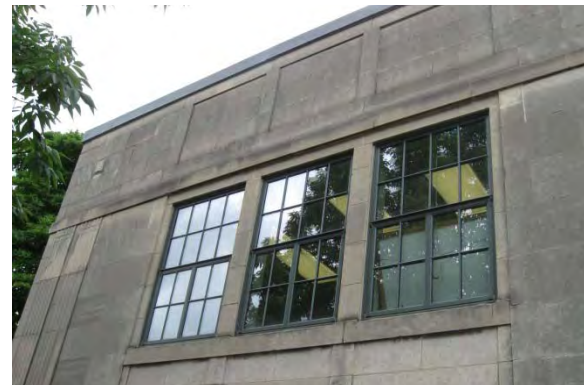
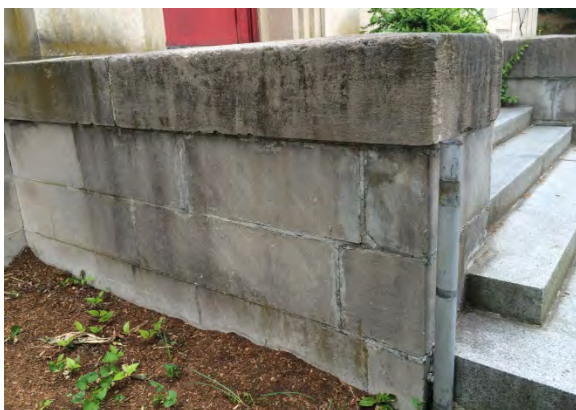
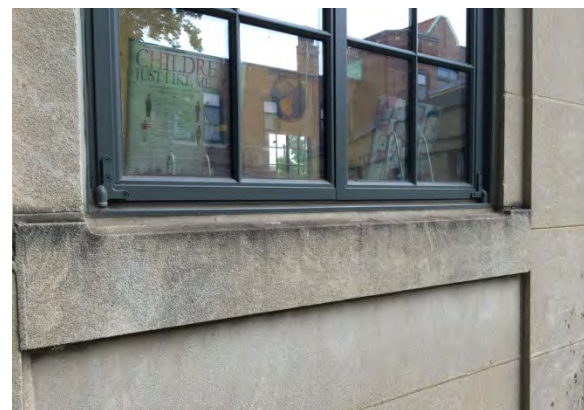
Some masonry deterioration can be observed at the front steps and flanking walls which should be addressed in the context of a capital improvement project.

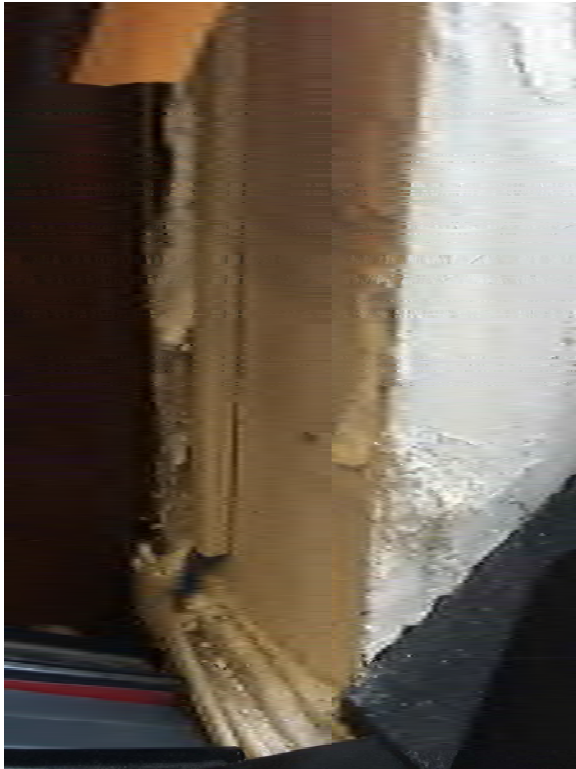
DETERIORATED PLASTER AT WINDOW JAMB

Despite the good condition of the windows, there appears to be some continued deterioration of the interior plaster at the jambs. It is not clear whether the deterioration is caused by water infiltrating from the outside or from condensation on the frames. The exterior masonry does show obvious deterioration that would lead to water infiltration. Blocking the flow of warm air from the perimeter radiation could precipitate the formation of condensation on the relatively cold window frames when the interior of the library is relatively warm and humid. However, this is not that common in library interiors, where the winter indoor environment is not mechanically humidified. Additional observation of these areas will be necessary to determine the cause

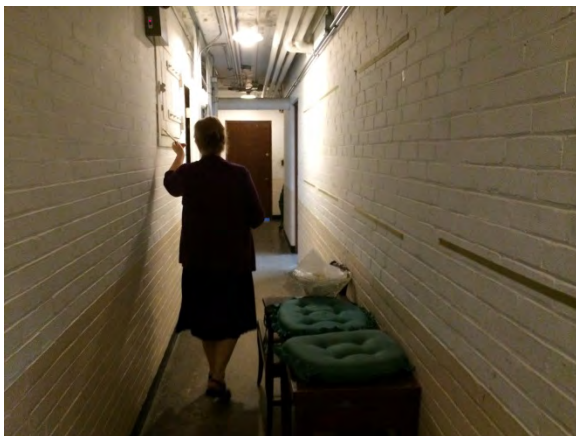
BASEMENT SPACES UNSUITABLE FOR PATRONS

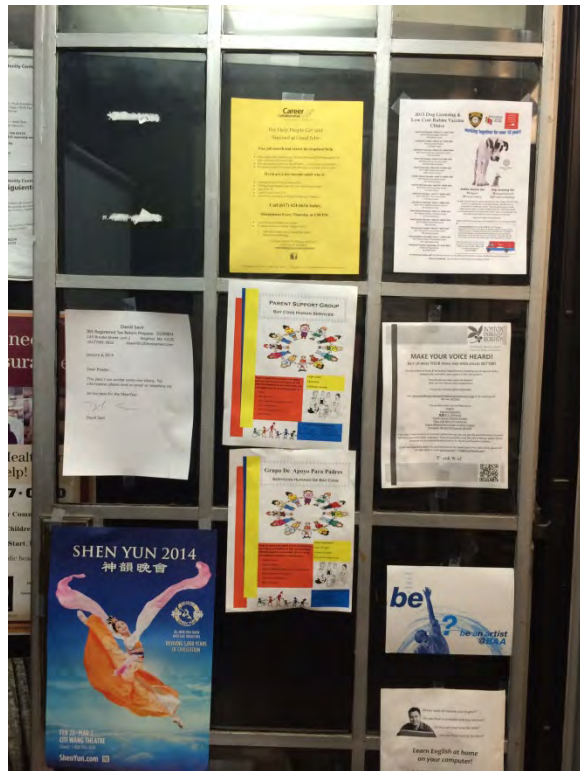
MISUSE OF BUILDING ATTRIBUTES

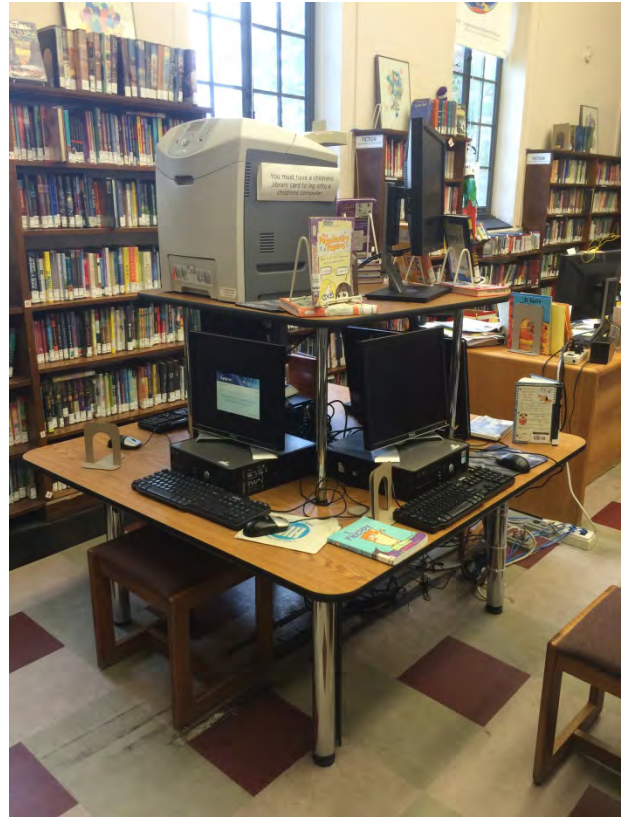
COMPUTERS IN CHILDREN'S NOT CHILD-FRIENDLY

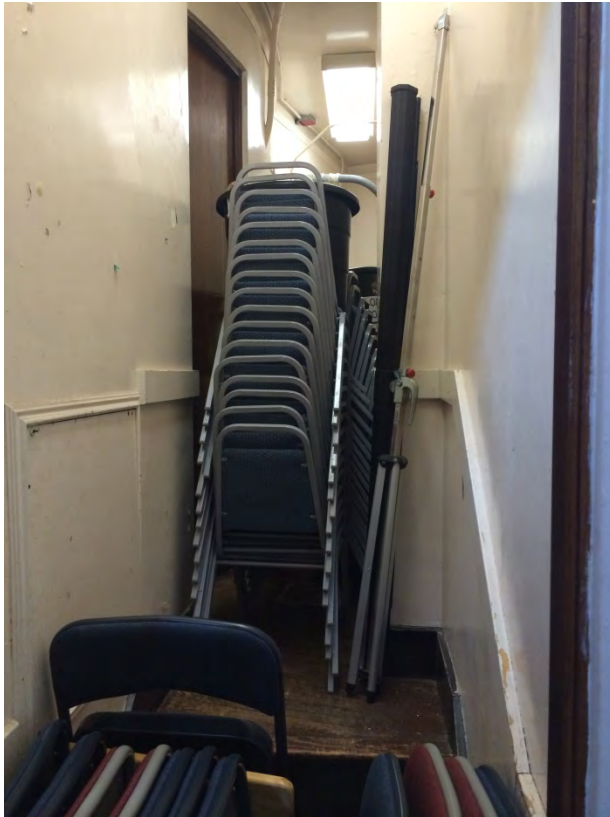
STORAGE BEHIND PLATFORM IS INCONVENIENT

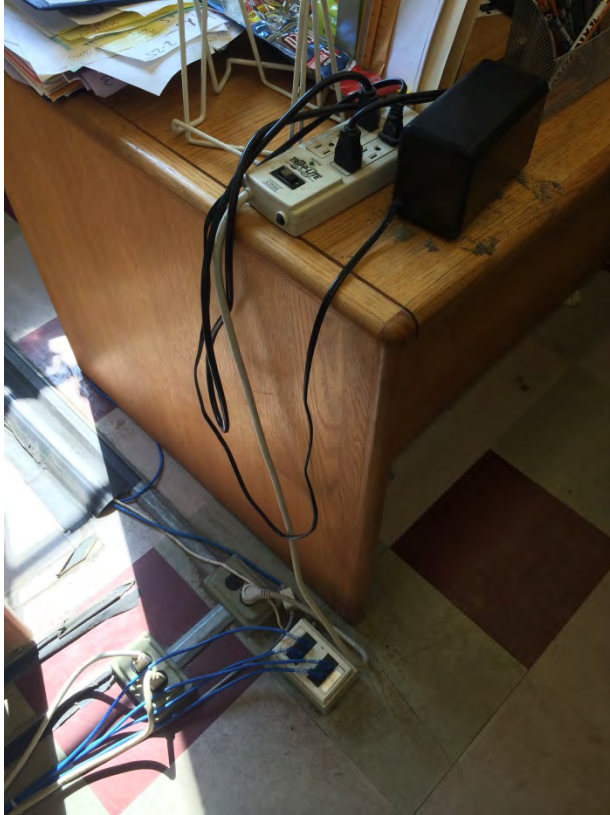
TECHNOLOGY NOT WELL ACCOMMODATED

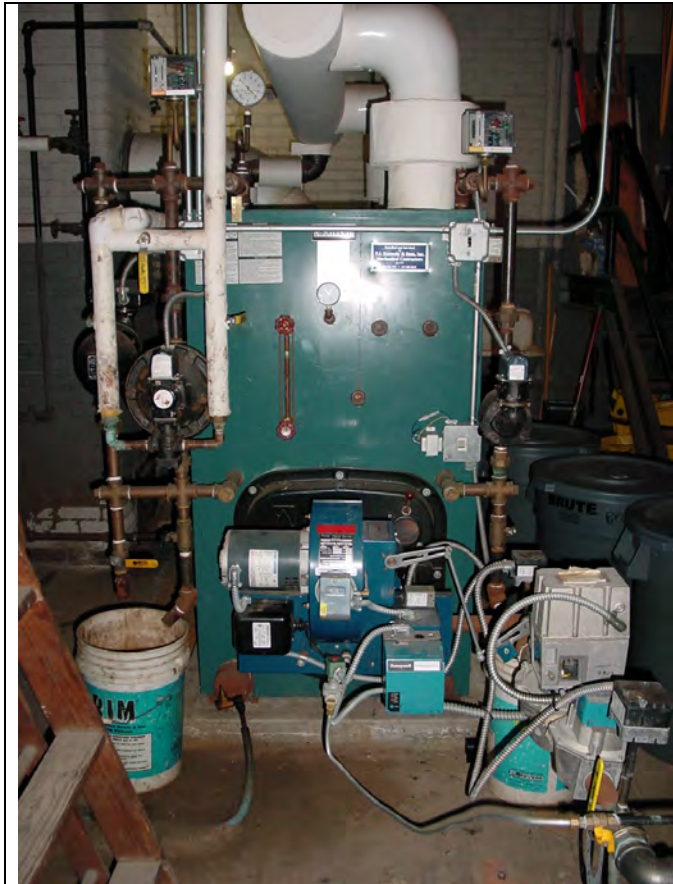
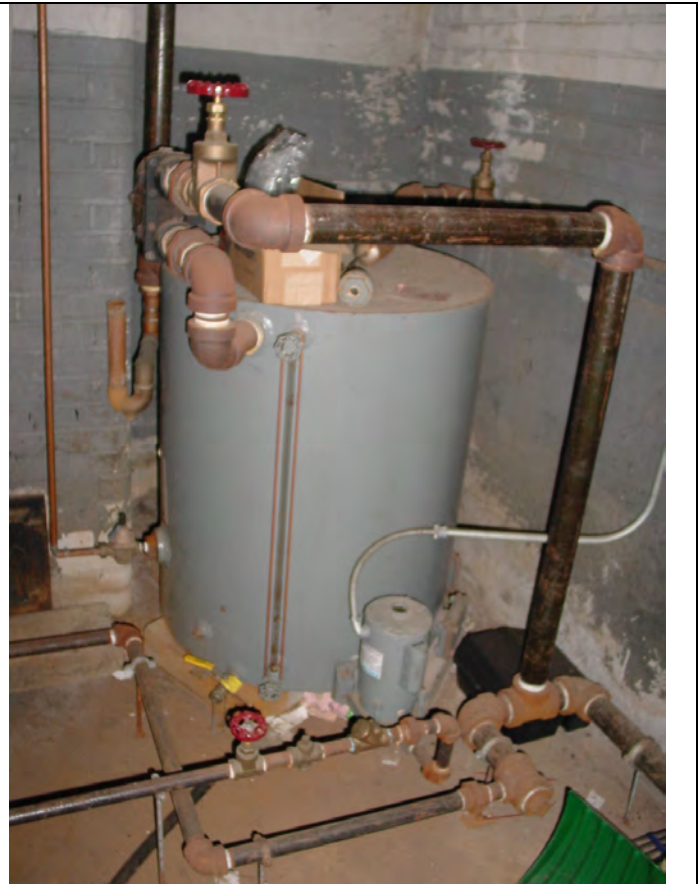
1. The building is currently occupied. Heating is provided by a gas-fired Burnham low pressure steam boiler located in the basement boiler room. The steam boiler has an output capacity of 1,342 MBH. Steam is piped to steam radiators and fin-tubes along the perimeters of the building to provide heating. Steam condensate is piped back to the condensate receiver (Hoffman Model 100VBES-B) and condensate pump located in the basement boiler room. The condensate pump pumps the condensate back to the boiler. The boiler was installed in 2001, and it is in fair condition. The original condensate pump was a duplex. However, only one pump is in place. The condensate receiver and pump seems to be in fair conditions.

The steam condensate receiver and the condensate pipes and accessories are not insulated.

For a major renovation of the building, we would recommend an entire new heating, ventilation and air-conditioning system using the high efficiency equipment, systems and technology available on the market, with a state-of-the-art direct digital control system to control and monitor the building systems function and performance.

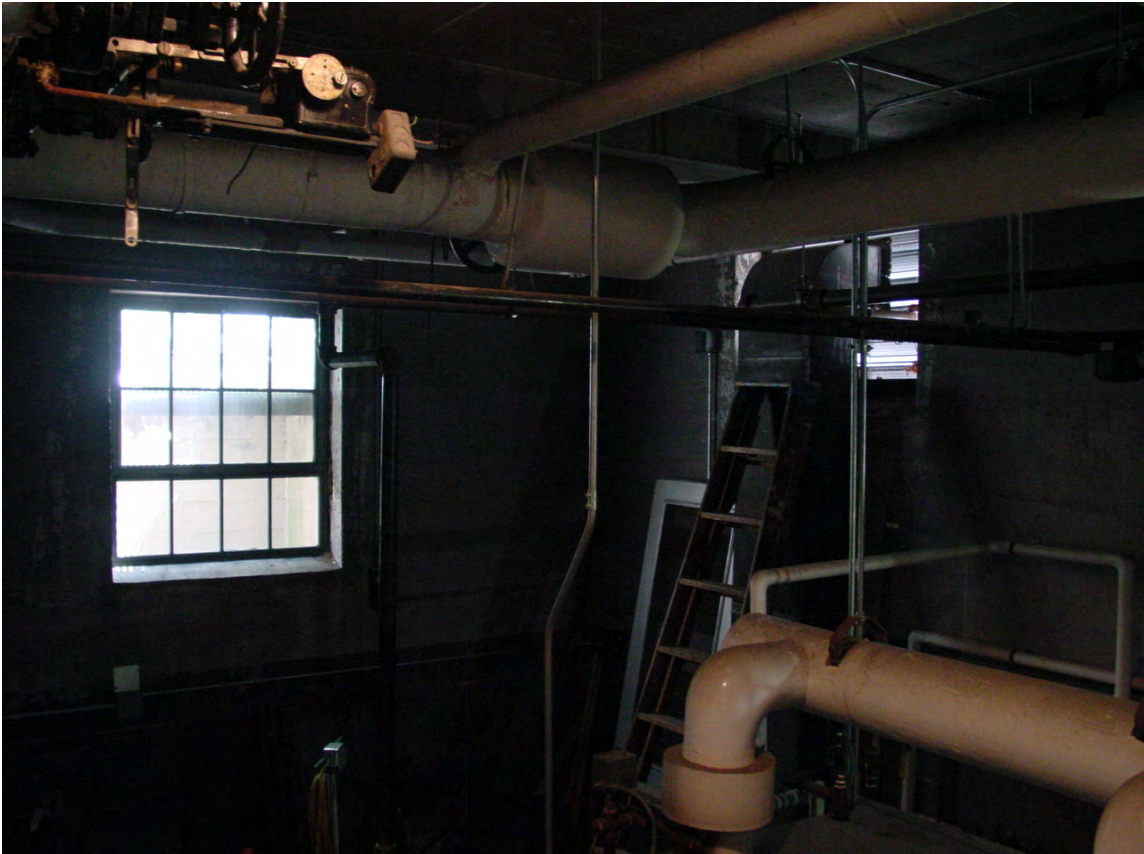
The boiler room is vented via a vertical duct placed behind a louver on the exterior wall. There is no plenum behind the louver, nor any dampers to close off the louver or the ventilation duct when the boiler is not running.

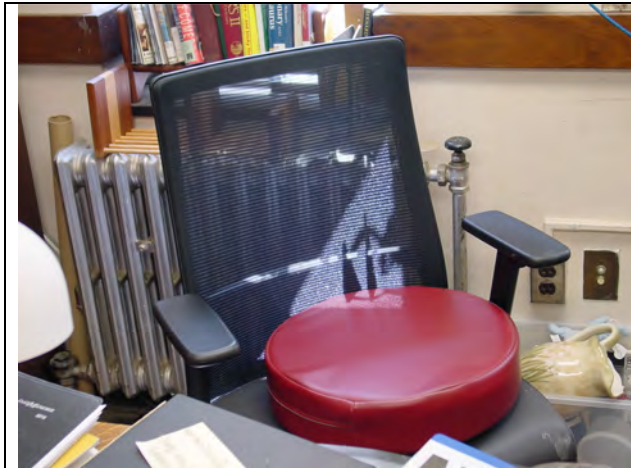
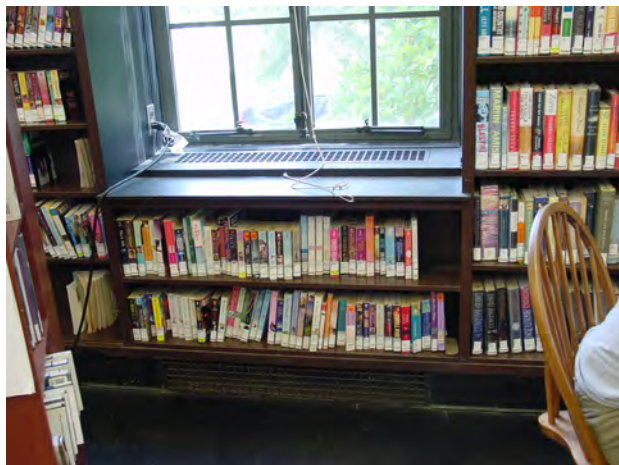
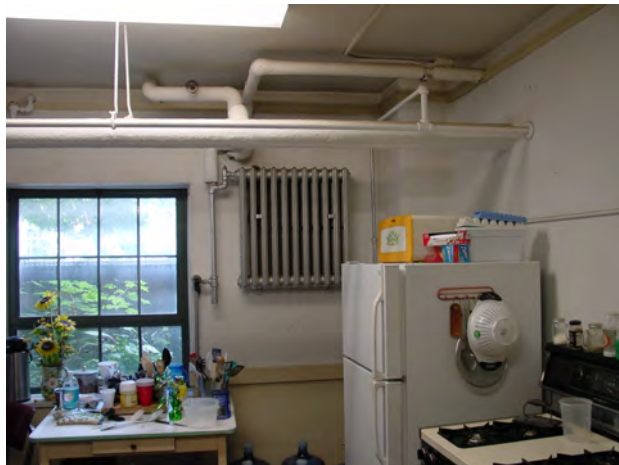
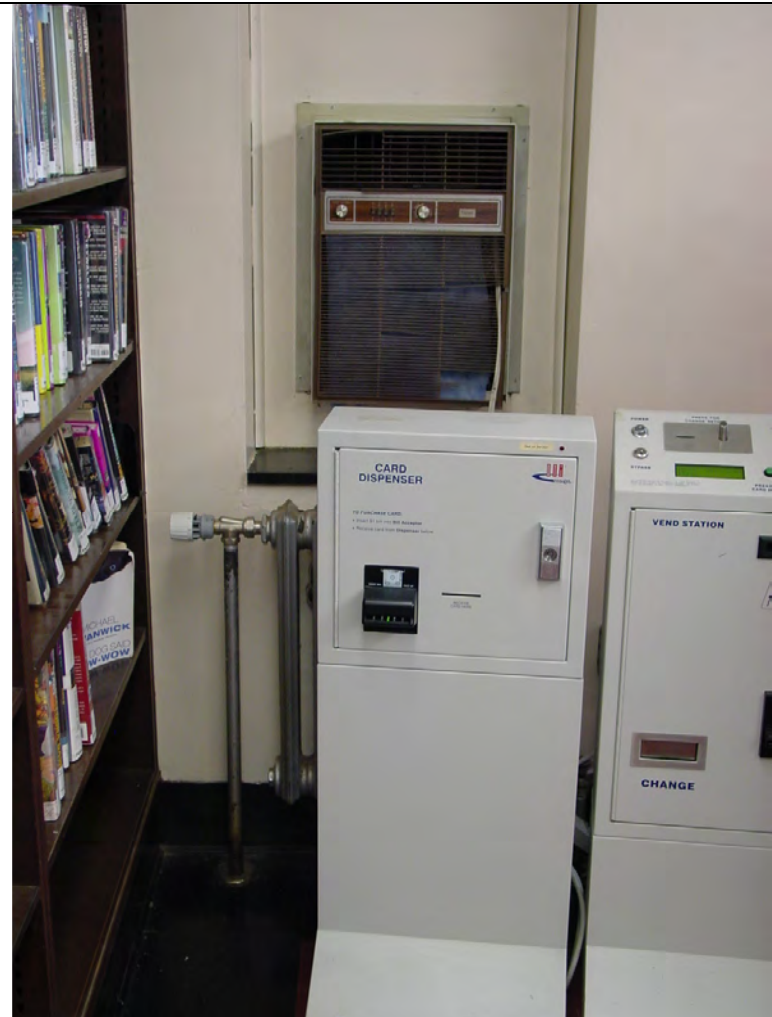
Perimeter steam radiators and fin-tubes are typically located under the windows. Some are blocked by book stacks or other furniture, negatively affecting their heating function. There are also radiators mounted at the middle height of a wall.

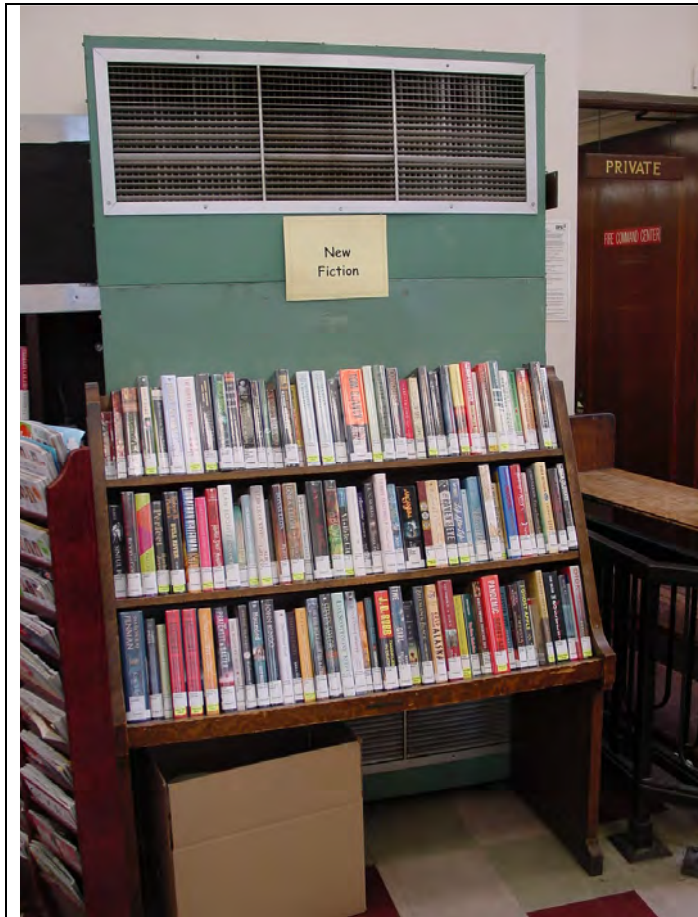
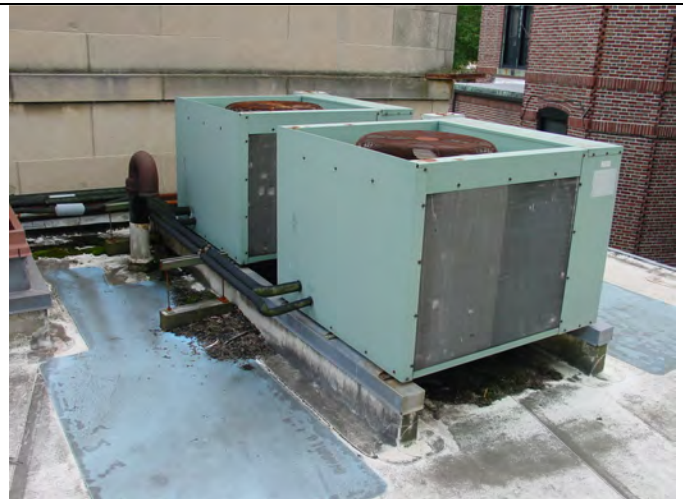
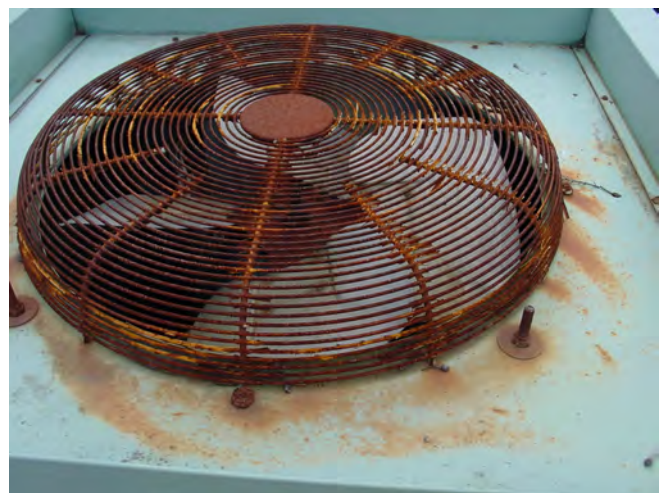
2. There are no central ventilation and air-conditioning systems to serve the entire building. In the two reading rooms at the front of the library on the first floor, there is a floor mount split type air-conditioning unit in each room. The condensing units for these two A/C units are located on the low roof. There are no dates on the A/C units. However, the

units look old. They are believed to have been installed during the 1989 renovation. The library staff reported that, while the units do provide adequate cooling, they are very noisy. The condensing units on the roof are rusted.

A/C units and book stacks are jammed together, not allowing proper clearance for good return airflow back to the units.

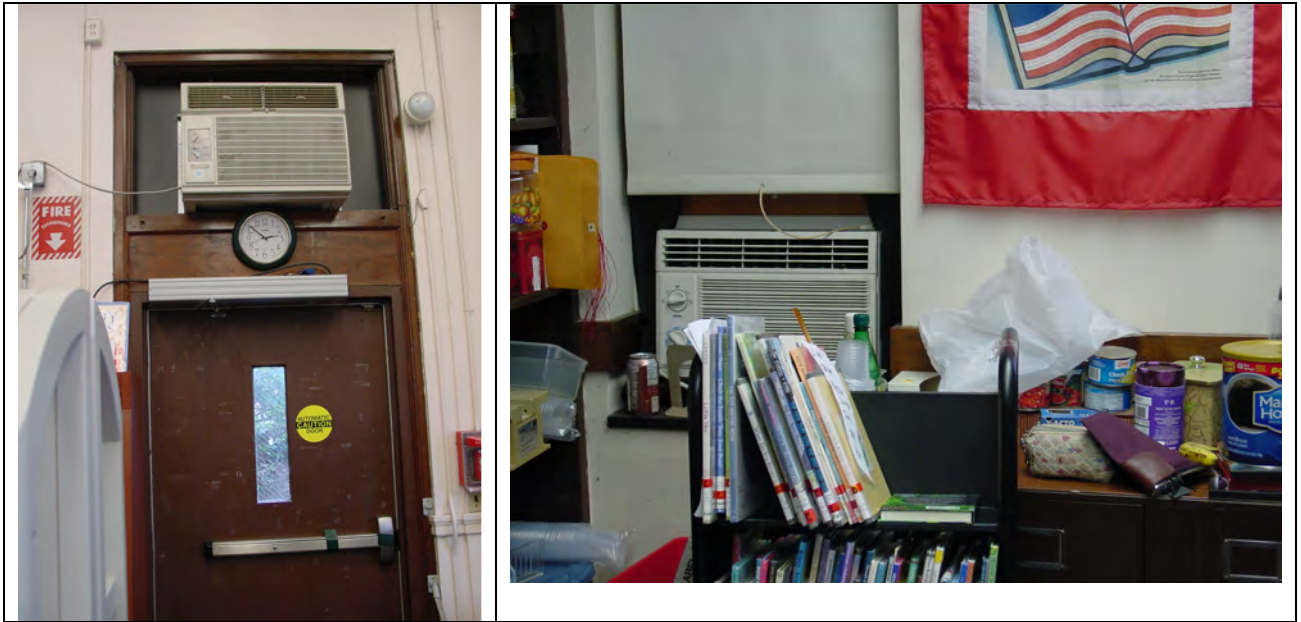
3. There are also a number of window-mount air-conditioners throughout the building providing local cooling.

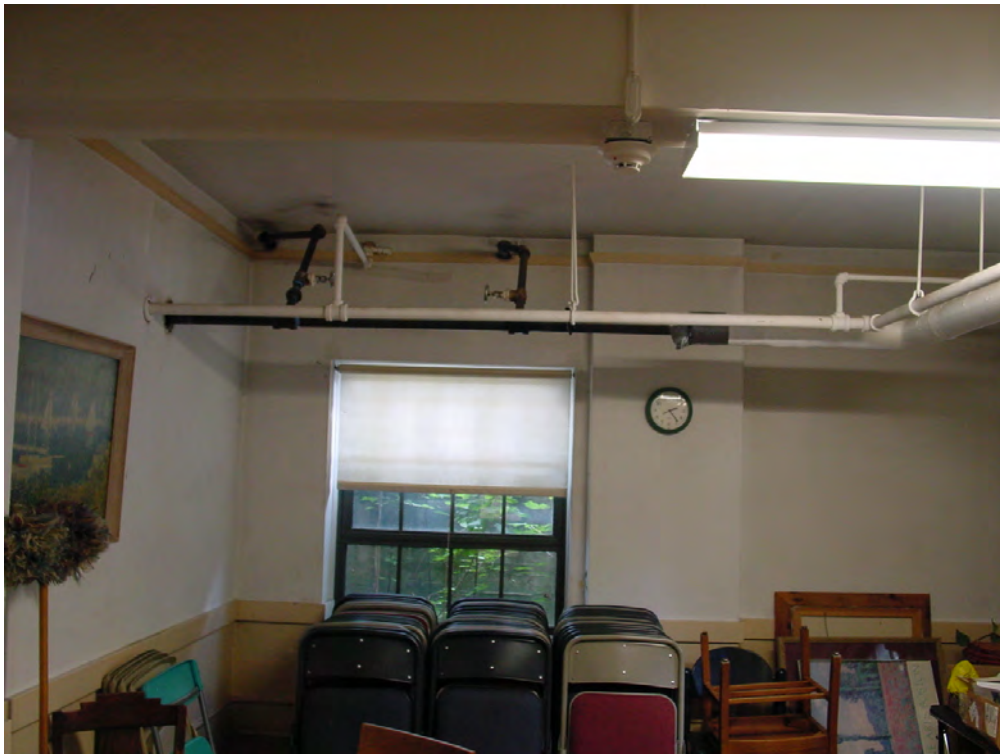
4. Some steam and condensate pipes are running in the occupied space, making the space look primitive and awkward.

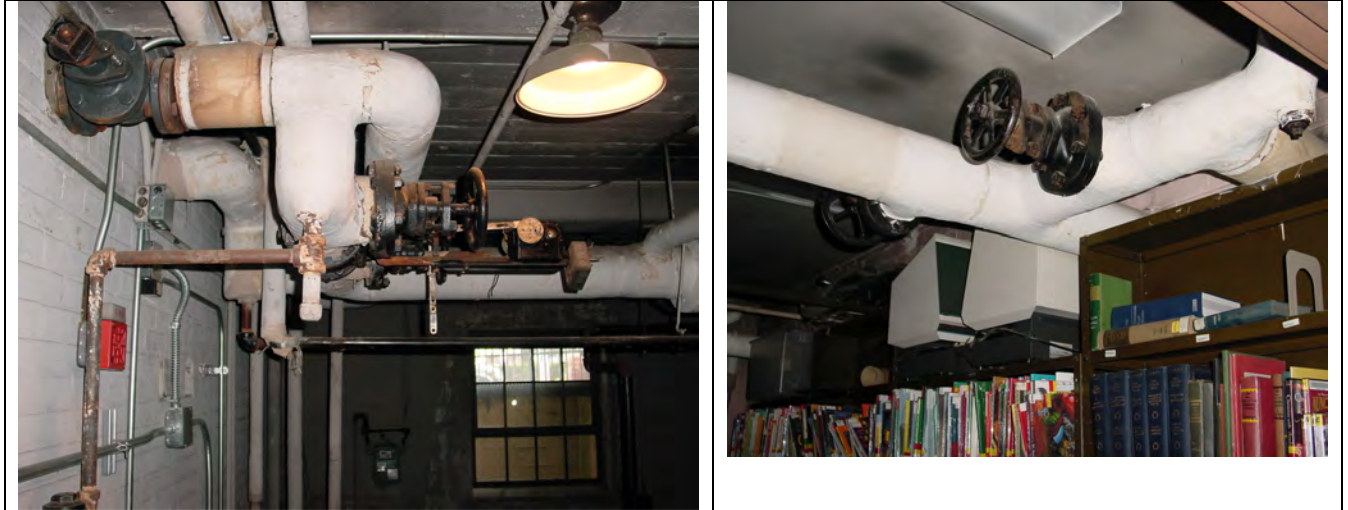
5. The original steam and condensate pipes have very old insulation on them. This insulation may contain asbestos.

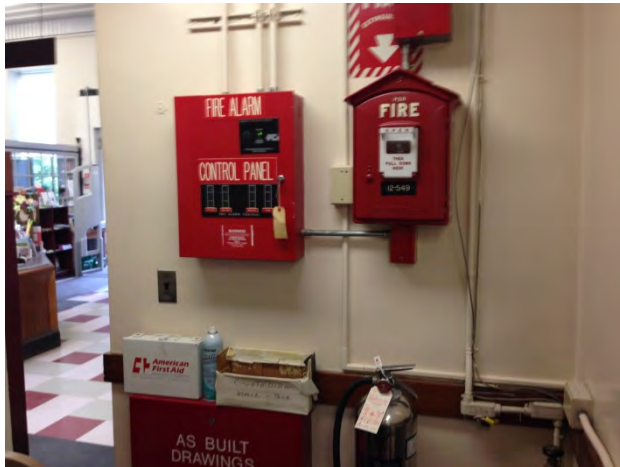
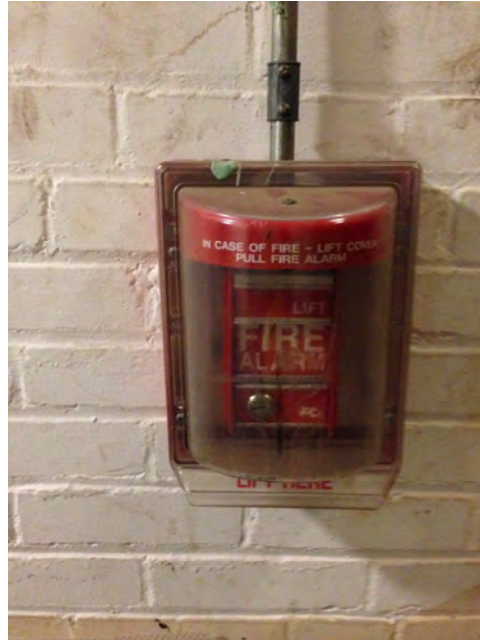
The existing fire alarm system a Federal Pacific fire alarm system installed in 1991. There are smoke detectors, pull stations and horn/strobe devices located throughout the library. The fire alarm is in fair condition and should be upgraded to meet the latest Fire Alarm codes.

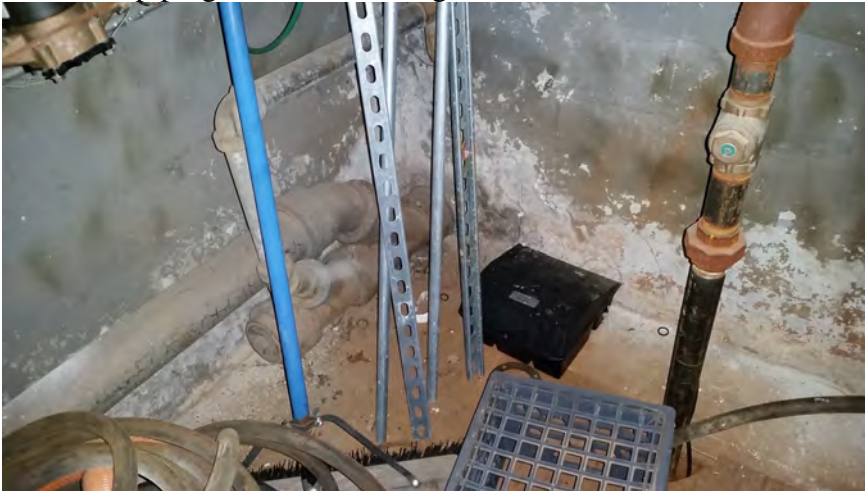
1. Existing Sanitary, Vent and Water piping is visibly aged and appeared to be in fair condition. The existing 4" Sanitary piping is located just above the basement floor slab, where the piping exits the building.

3. Existing underground sanitary piping should be professionally scoped with camera and recorder to determine the condition of the piping is in useable condition or if piping should be replaced with new. Replace with new underground service if determined piping is not usable.

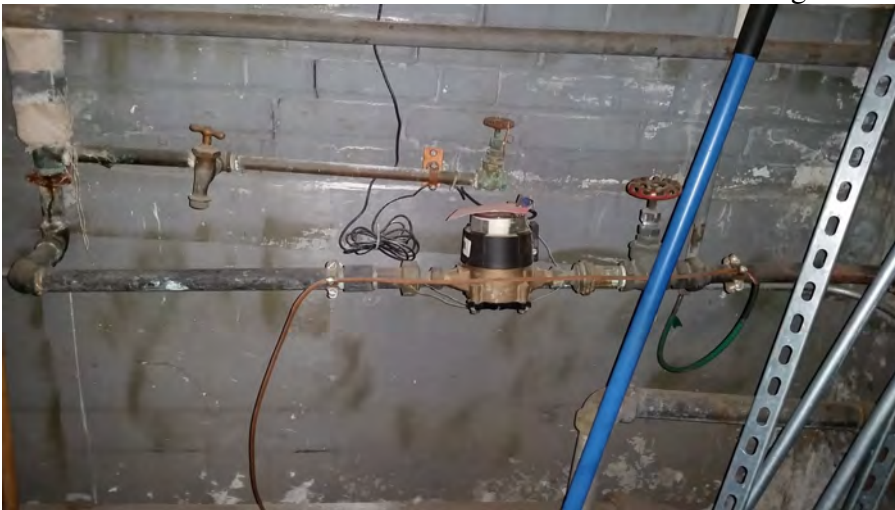
2. Existing Incoming Domestic Water piping is 3/4" with a 5/8" water meter and remote reader. Remote reader is located on the exterior of the building.

4. Remove and replace existing domestic water service with new larger service as required. If building fixture count, fixture types and usage is to remain as currently exists, existing piping to be inspected and reused if determined piping is in useable condition.

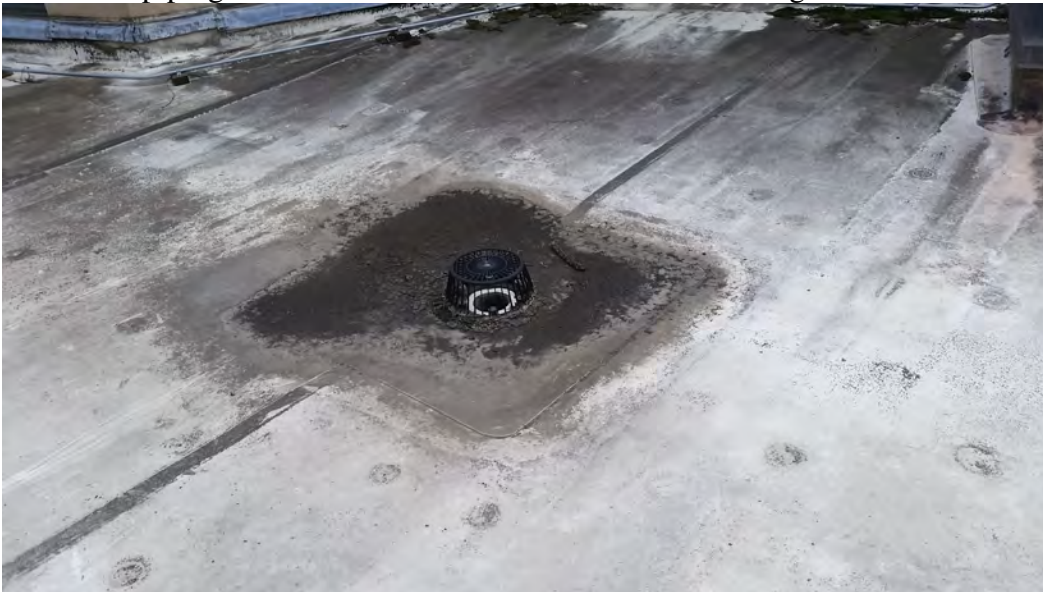
7. The existing toilet room fixtures are outdated and in poor condition.
8. The building is equipped with existing roof drains. The condition of the roof drains and associated piping is unknown as this was not accessible during the time of the site visit.

9. The existing piping insulation is old and likely contains asbestos

1. Remove all existing piping and insulation and replace with new. Consult with an asbestos abatement specialist to remove all asbestos safely.
2. Remove and replace existing wall hydrants with new frost proof vacuum breaker type hydrants.
