Draft report for discussion purposes only – 12/11/2014

Faneuil Branch Library EXISTING CONDITIONS

INTRODUCTION

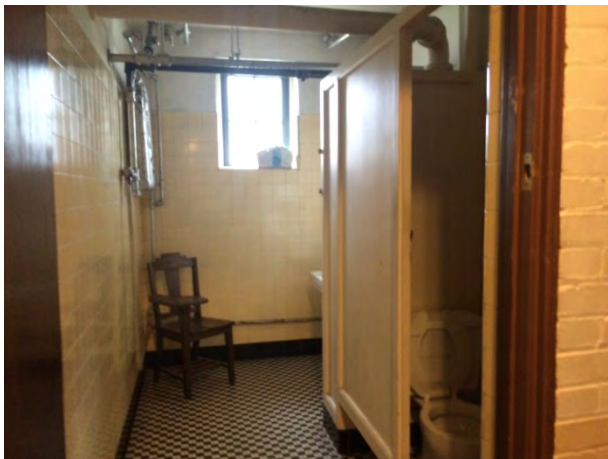
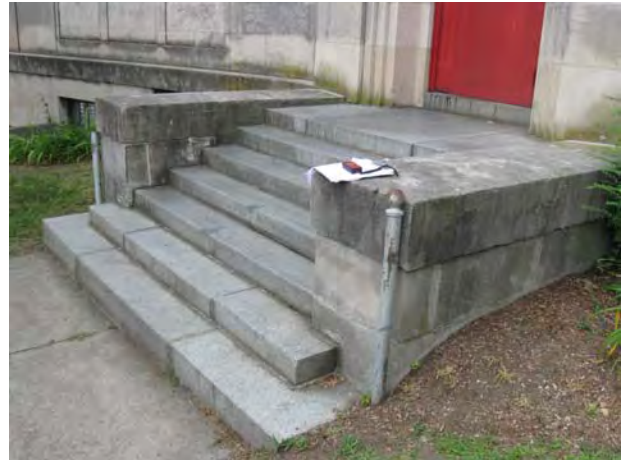
Public Toilet facilities are located on the inaccessible lower level. This scenario makes it very difficult for a parent to escort a child to the toilet, as well as making it impossible to serve wheelchair bound patrons or patrons with ambulatory issues.

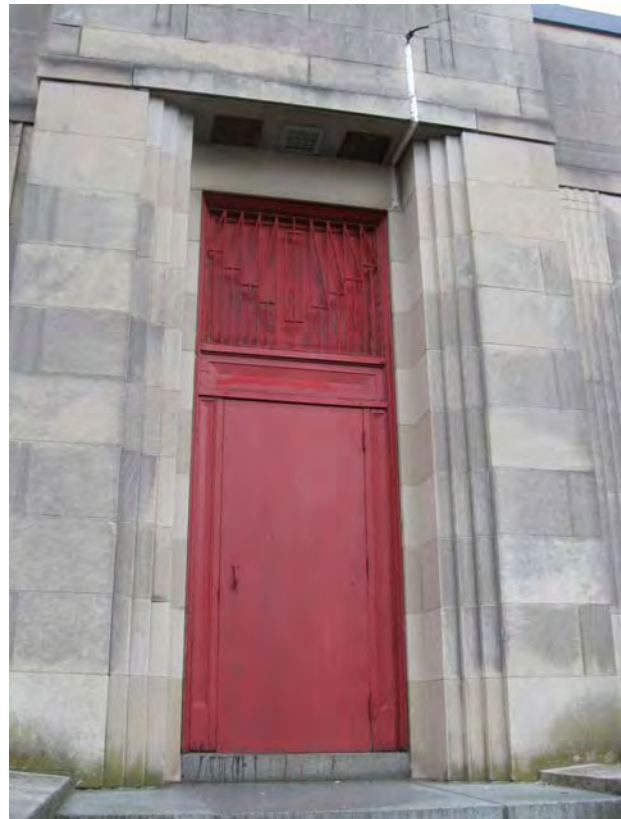
The Bigelow street entrance is also not accessible (although not used as an entrance since the meeting room was transitioned to Children’s Wing.

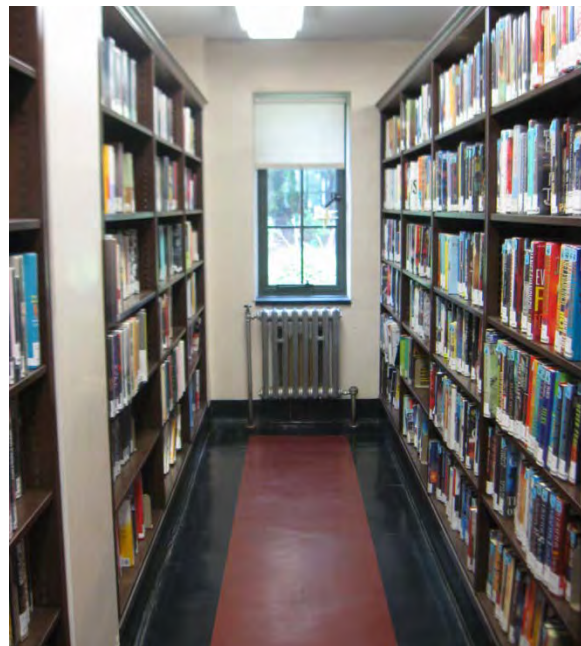
In the space behind the service desk, some of the original bookstacks have been removed (to make space for the library's computer center), but the shelving that remains creates dead-end aisles that are not compliant with ADA requirements for wheelchair access.

NON-COMPLIANT DEAD-END SHELVING AISLE

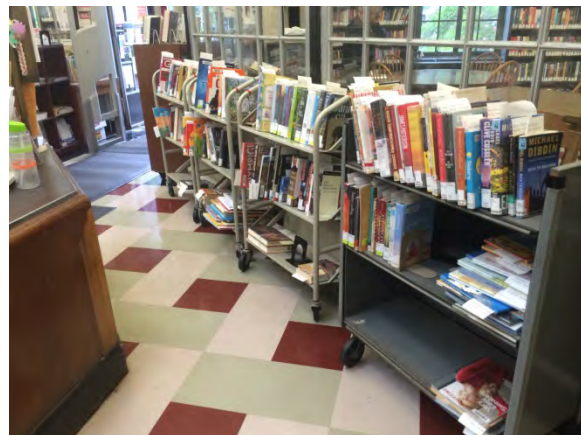
HOLDS CROWDS CIRCULATION SPACE

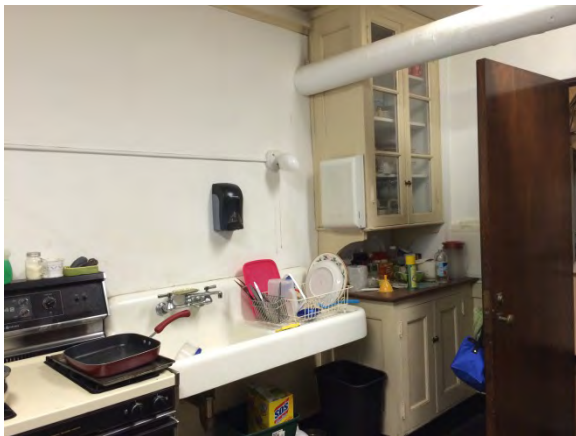
STAFF BREAK ROOM

The basement staff break room has deteriorated finishes, is equipped with salvaged appliances and repurposed book shelves and is wholly sub-standard and should be slated for comprehensive renovation.

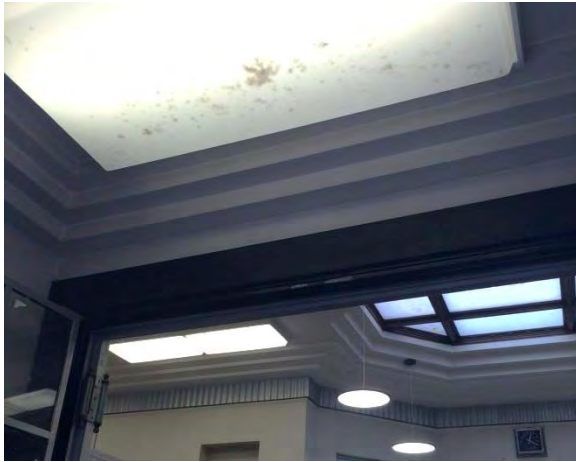
Plumbing system is sub-standard and should be completely replaced and upgraded, including all fixtures and distribution. A larger service from the street will also be required.

Original lighting has been replaced throughout the building with fixtures that are not compatible with the original design intent, do not appropriately or adequately light the spaces, and are not as energy efficient as replacement fixture would be.

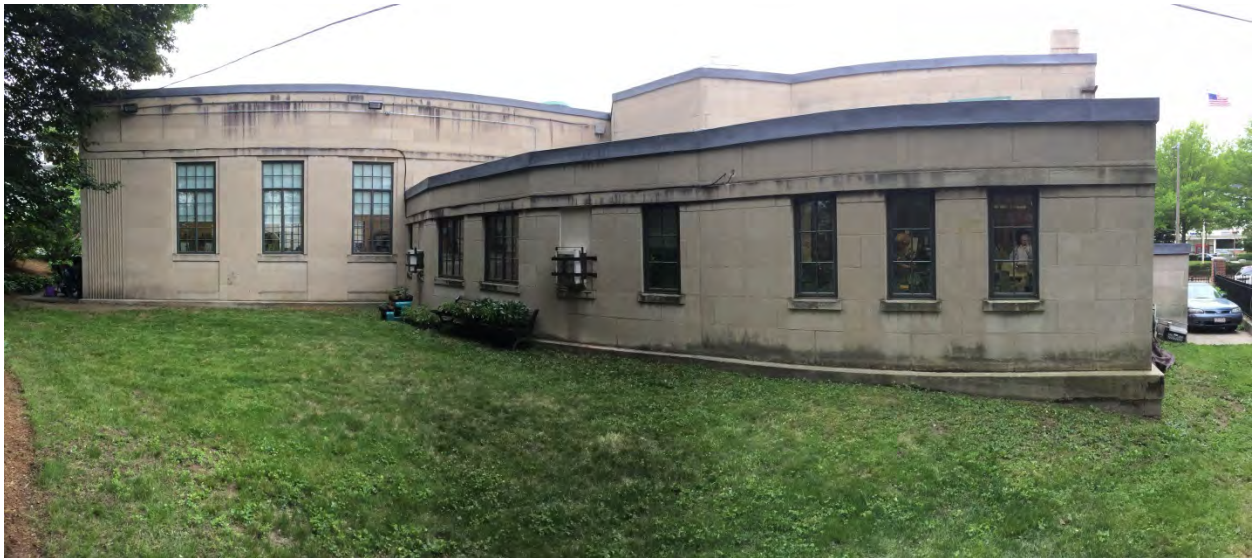
As noted earlier, the exterior of the building is in relatively good condition. The masonry does not show signs of structural distress and although it has an aged patina is not generally stained and dirty.

Some masonry deterioration can be observed at the front steps and flanking walls which should be addressed in the context of a capital improvement project.

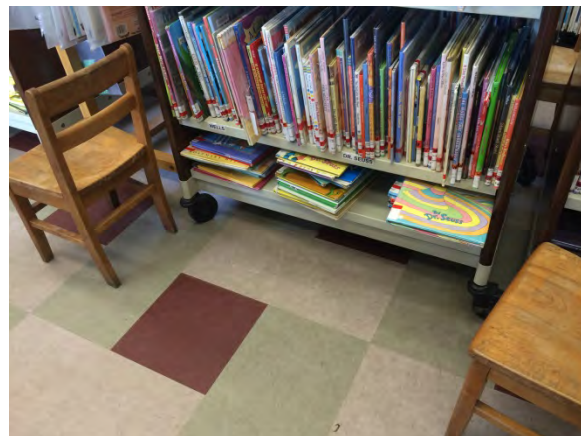
FLOORING IN CHILDREN'S

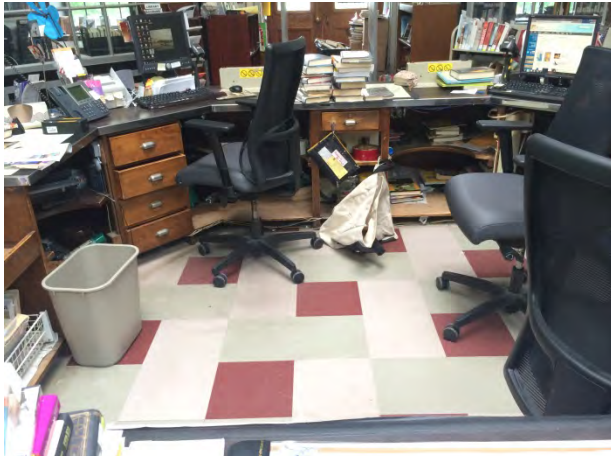
FLOORING AT MAIN DESK

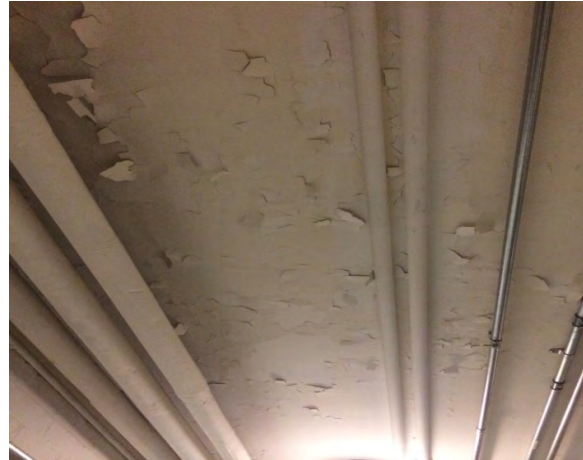
PEELING PAINT IN BASEMENT

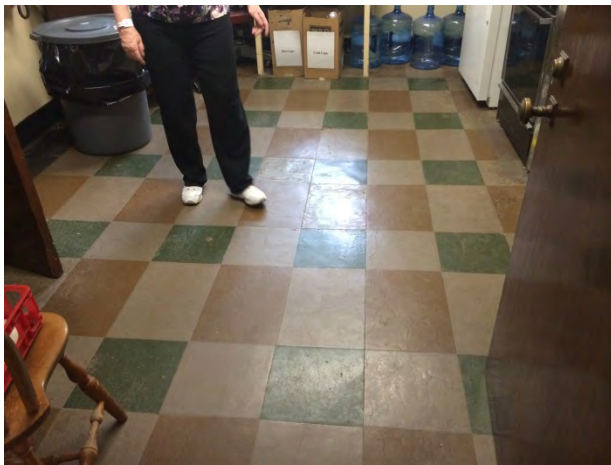
FLOORING IN BASEMENT

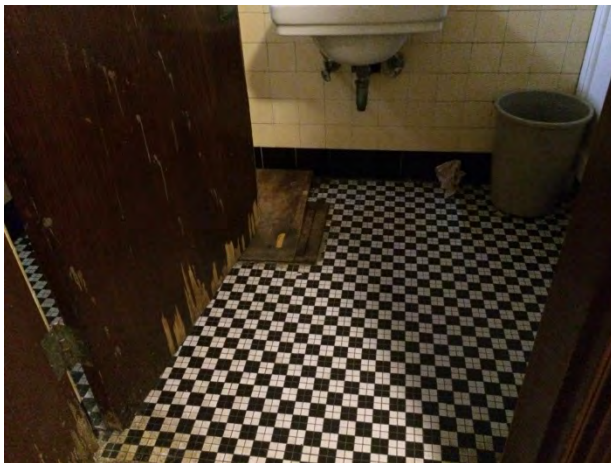
FLOORING AT TOILET ROOM

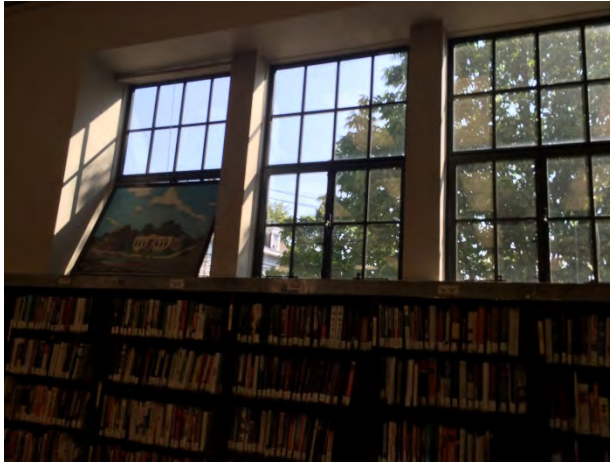
**HIGH WINDOWS PROVIDE EXCELLENT DAYLIGHT
(AUTOMATED SHADES WOULD BE BENEFICIAL)**

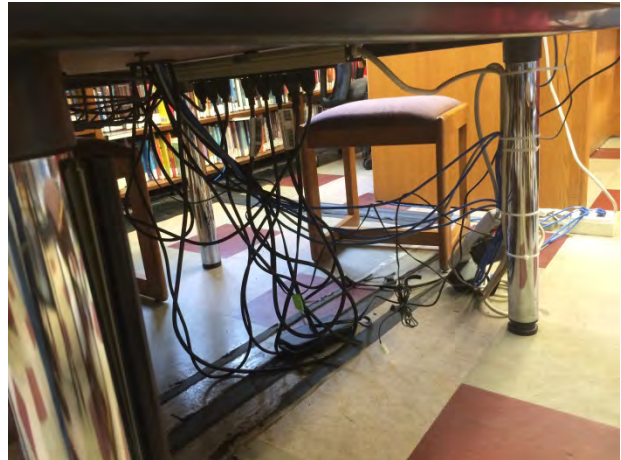
TECHNOLOGY NOT WELL ACCOMMODATED

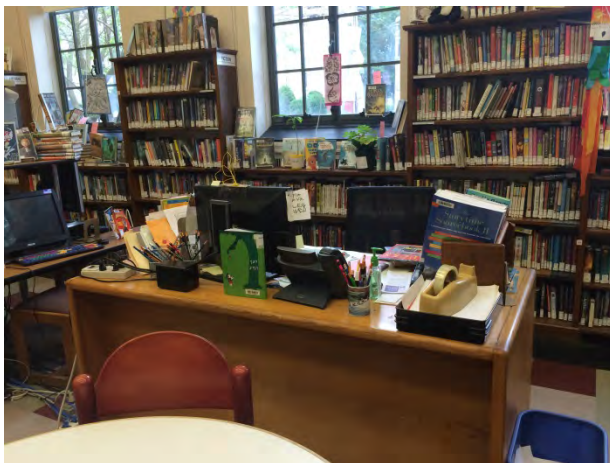
CHILDREN'S DESK NOT CHILD-FRIENDLY
